Manhole Inspection Summary

Manhole # S45E__022MH

Insp Date: **7/22/08 10:44 AM**

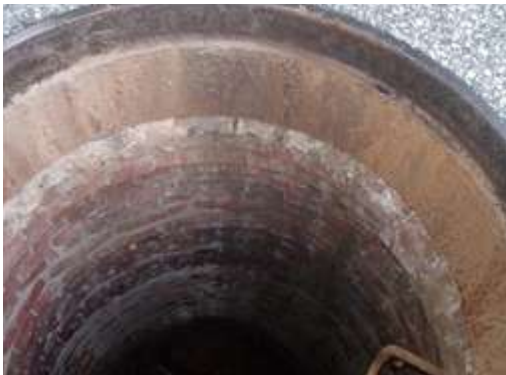
Defect 2

☒ **Leaks**

Frame Leaks

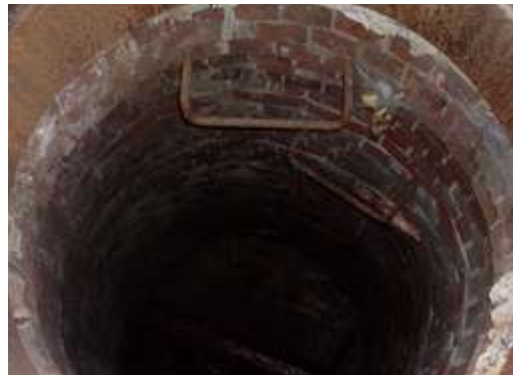
Defect 1

Infiltration: ☐ None ☒ **Joint** ☐ Cracks ☐ Mortar ☐ Roots ☐ Wall

Infiltration: ☐ None ☐ Joint ☐ Cracks ☐ Mortar ☐ Roots ☒ **Wall**

Infiltration

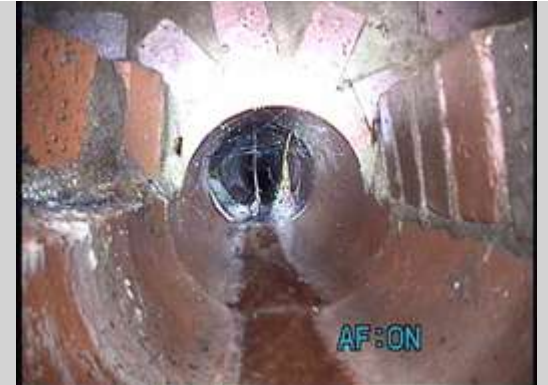
12 O'Clock Outflow

8 in. Circular Gravity Sewer
Pipe Out @ 12 O'Clock

Pipe Height: **8.4** (in.) Rod and Bar (Angled)
Pipe Material: **Clay** ☐ Pipe Lined
Invert Depth: **10.35** (ft.) Flow Characteristics: **Fast**
Deposits: ☒ None ☐ Mud ☐ Sludge ☐ Debris ☐ Grease
Silt Depth: (in.) Deposits Extent:
Infiltration: **None** Pipe Seal Cond: **Sound**

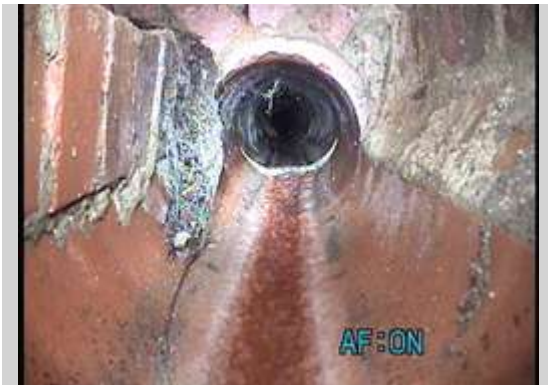
6 O'Clock Inflow

8 in. Circular Gravity Sewer
Pipe In @ 6 O'Clock

Pipe Height: **8.4** (in.) Rod and Bar (Angled)
Pipe Material: **Clay** ☐ Pipe Lined
Invert Depth: **10.20** (ft.) Flow Characteristics: **Fast**
Deposits: ☒ None ☐ Mud ☐ Sludge ☐ Debris ☐ Grease
Silt Depth: (in.) Deposits Extent:
Infiltration: **None** Pipe Seal Cond: **Sound**

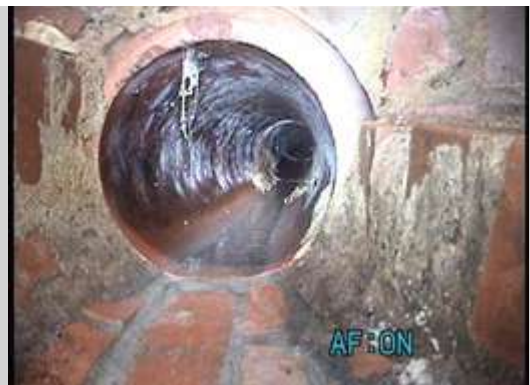
9 O'Clock Inflow

8 in. Circular Gravity Sewer

Pipe In @ 9 O'Clock

Pipe Height: **8.4** (in.) Rod and Bar (Angled)

Infiltration: **None** Pipe Seal Cond: **Sound**
